Manhole Inspection Summary

Manhole # S15QQ1013MH

Insp Date: **6/25/07 8:57 AM**

Location Address: **2440 CLYBURN AVE**

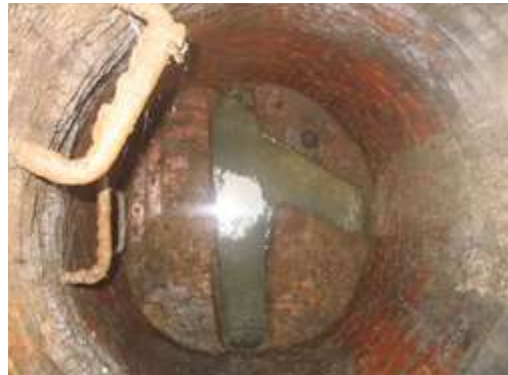
Top View

Corroded steps. Evidence of surcharge - Bench debris. Channel debris.

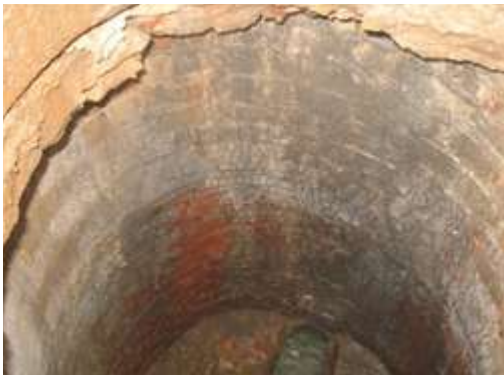
Defect

Frame leaks. Frame offset. Adjustment deterioration and infiltration - other side.

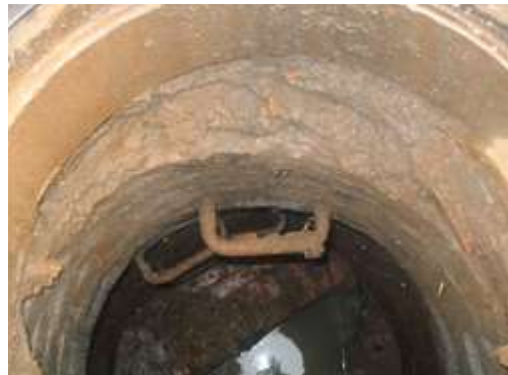
Defect

Frame leaks. Frame offset. Adjustment deterioration and infiltration.

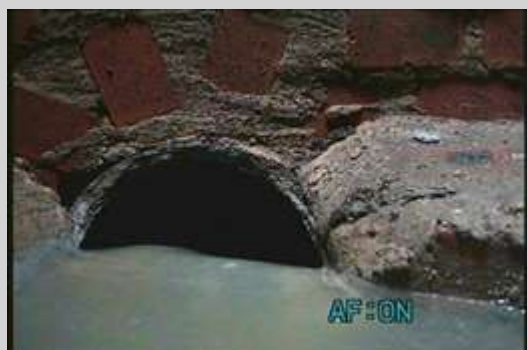
Pipe Out @ 12 O'Clock

Deposits: ☐ None ☒ **Mud** ☐ Sludge ☒ **Debris** ☐ Grease

Silt Depth: **1.5** (in.) Deposits Extent: **Light**

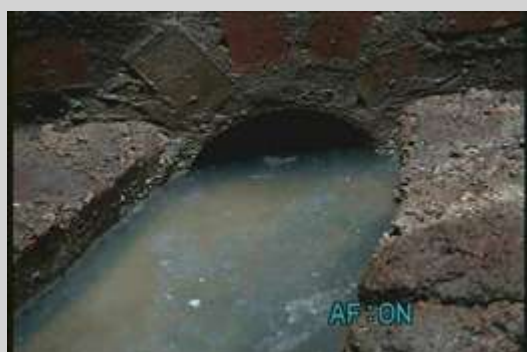
Pipe In @ 3 O'Clock

Deposits: ☐ None ☒ **Mud** ☐ Sludge ☒ **Debris** ☐ Grease

Silt Depth: **4** (in.) Deposits Extent: **Heavy**

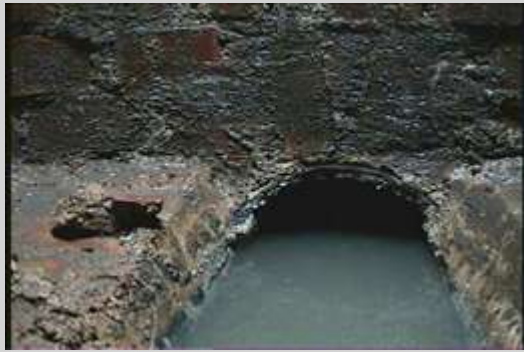
Pipe In @ 6 O'Clock

Deposits: ☐ None ☒ **Mud** ☐ Sludge ☒ **Debris** ☐ Grease

Silt Depth: **4** (in.)

Deposits Extent: **Heavy**
